INDOOR AIR QUALITY REASSESSMENT

**Mixer Municipal Office Building
120 Prescott Street
West Boylston, Massachusetts**

Prepared by:
Massachusetts Department of Public Health
Center for Environmental Health
Emergency Response/Indoor Air Quality Program
March 2007

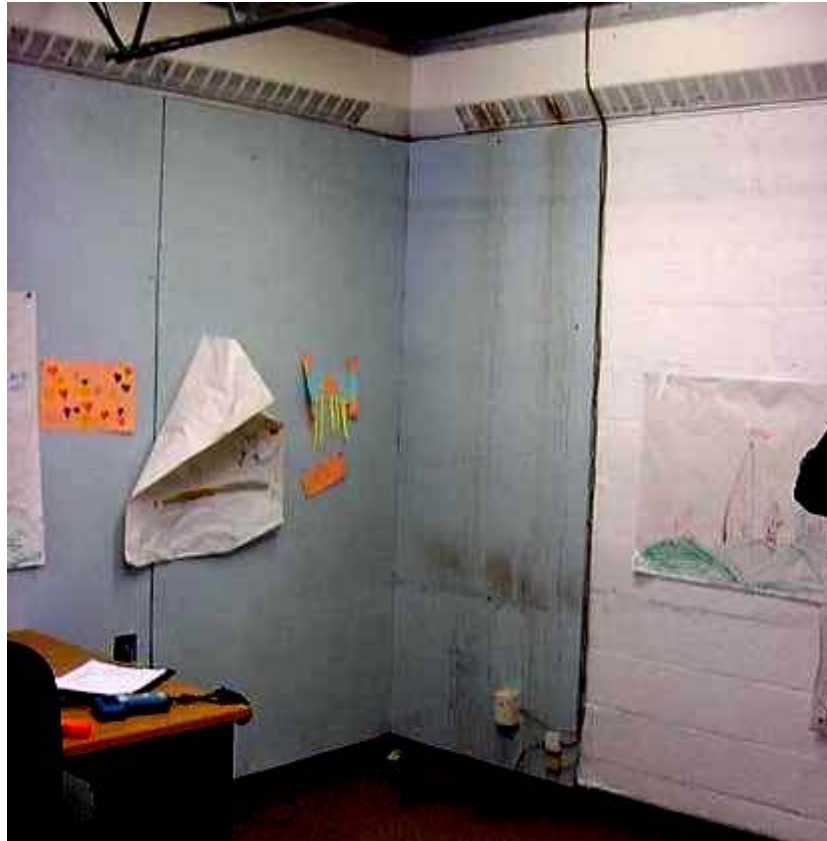
Picture 1

Upon entering the building, a distinct musty odor was detected inside the front lobby that extended to the area outside the Town Administrator's office. The most prominent source of musty odors was traced to the Town Administrator's office. CEH staff observed evidence of a current roof leak in the form of stained gypsum wallboard (GW) and carpeting (Pictures 1 and 2) within the Town Administrator's Office. Moisture measurements were taken of the GW and carpeting and both were found to have elevated moisture content at the time of the visit. The

Active Roof Leak, Water Damaged Gypsum Wallboard and Carpeting in Town Manager's Office, Note Carpet and Wall were Moistened at the Time of the Assessment

3. Remove and replace any mold contaminated/water damaged materials (e.g., carpeting, cork board, GW). This measure will remove actively growing mold colonies that may be present. Remove mold contaminated materials in a manner consistent with recommendations found in “Mold Remediation in Schools and Commercial Buildings” published by the US Environmental Protection Agency (US EPA, 2001). Copies of this document can be downloaded from the US EPA website
at: http://www.epa.gov/iaq/molds/mold_remediation.html

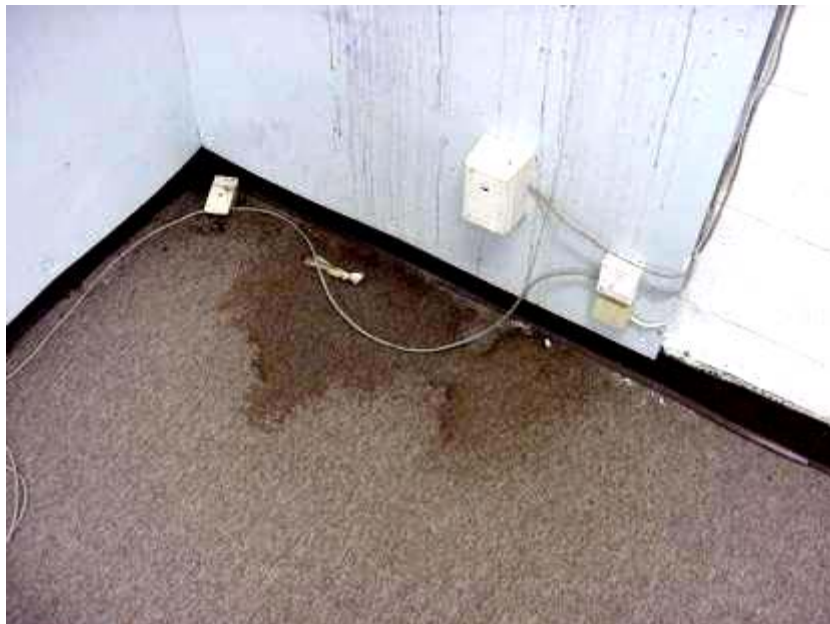
Picture 2

Close-Up of Water Damaged Carpet in Town Manager's Office, Note Carpet and Wall were Moistened at the Time of the Assessment

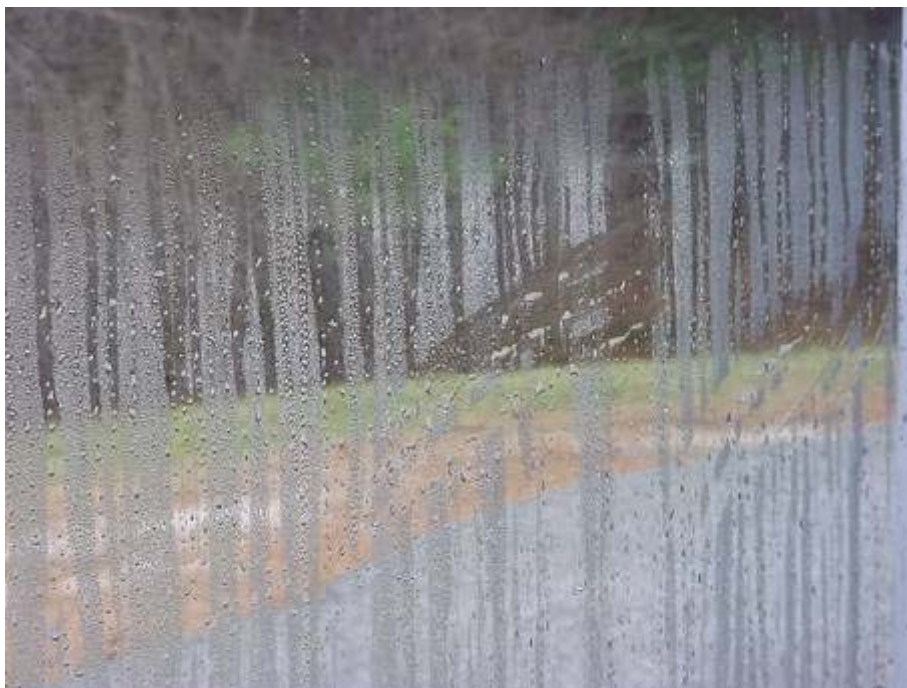
Picture 3

Condensation on Interior of Window of Town Administrator's Office

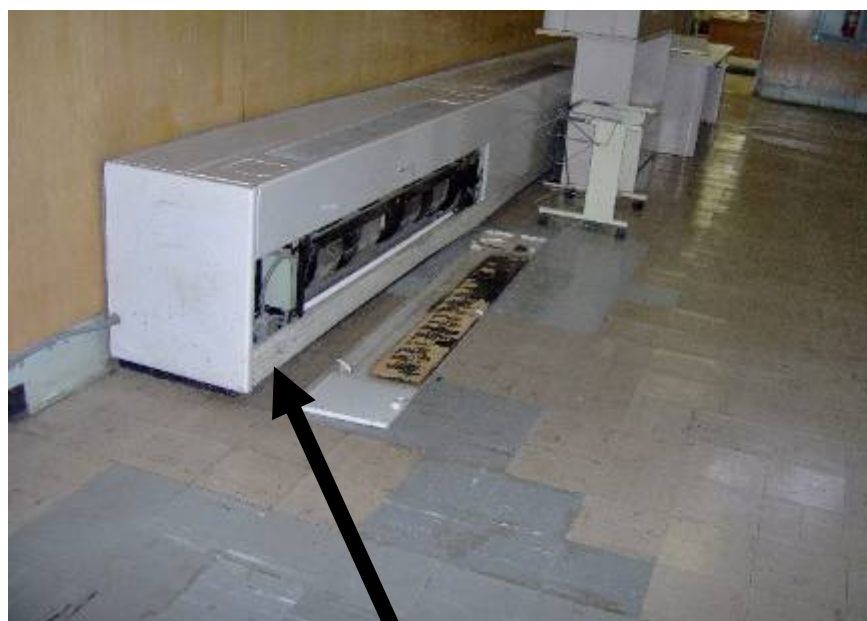
Picture 4

means for this odor travel from the Town Administrator's office to the lobby at the front door appears to be components of the heating, ventilating and air-conditioning (HVAC) system. A bank of univents exists in a large room (presumably originally used as the school's gymnasium). Each univent draws air from the floor through their return vents (Picture 4). It is likely that these univents are drawing air from the Town Administrator's office and distributing odors into other areas of the building via main hallways. Odors can then be drawn to the front lobby by a functioning exhaust vent located near the front entrance (likely the former nurse's office). It is worthy to note that no similar odor was detected in the former cafeteria on the opposite side of the building, now used as the senior center.

Return Vent

Univent outside Town Administrator's Office

8. Remove all blockages from univent air diffusers and return vents (bottom front of units) to facilitate airflow.
9. For buildings in New England, periods of low relative humidity during the winter are often unavoidable. Therefore, scrupulous cleaning practices should be adopted to minimize common indoor air contaminants whose irritant effects can be enhanced when the relative humidity is low. To control for dusts, a high efficiency particulate arrestance (HEPA) filter equipped vacuum cleaner in conjunction with wet wiping of all surfaces is recommended. Avoid the use of feather dusters. Drinking water during the day can help ease some symptoms associated with a dry environment (throat and sinus irritations).

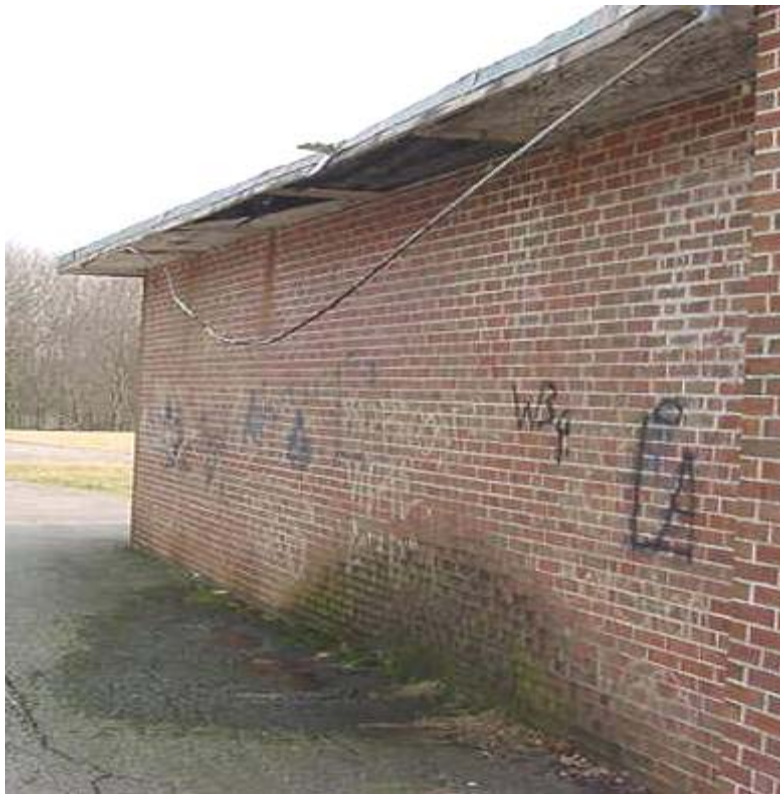
Picture 5

The building has a well-documented history of roof leaks. As indicated in [Appendix A](#), attempts are reportedly made to patch/repair leaks; however active leaks continue to persist. Severely water-damaged wood along the eaves of the roof was observed (Pictures 5 through 7). In order for building materials to support mold growth, a source of water exposure is necessary. Identification and elimination of water moistening building materials is necessary to control mold growth (in this case leaks through the building envelope). Materials with increased moisture content *over normal* concentrations may indicate the possible presence of mold growth.

Severely Rotted Roof Eave and Backsplash/Moss Growth on Exterior Brick

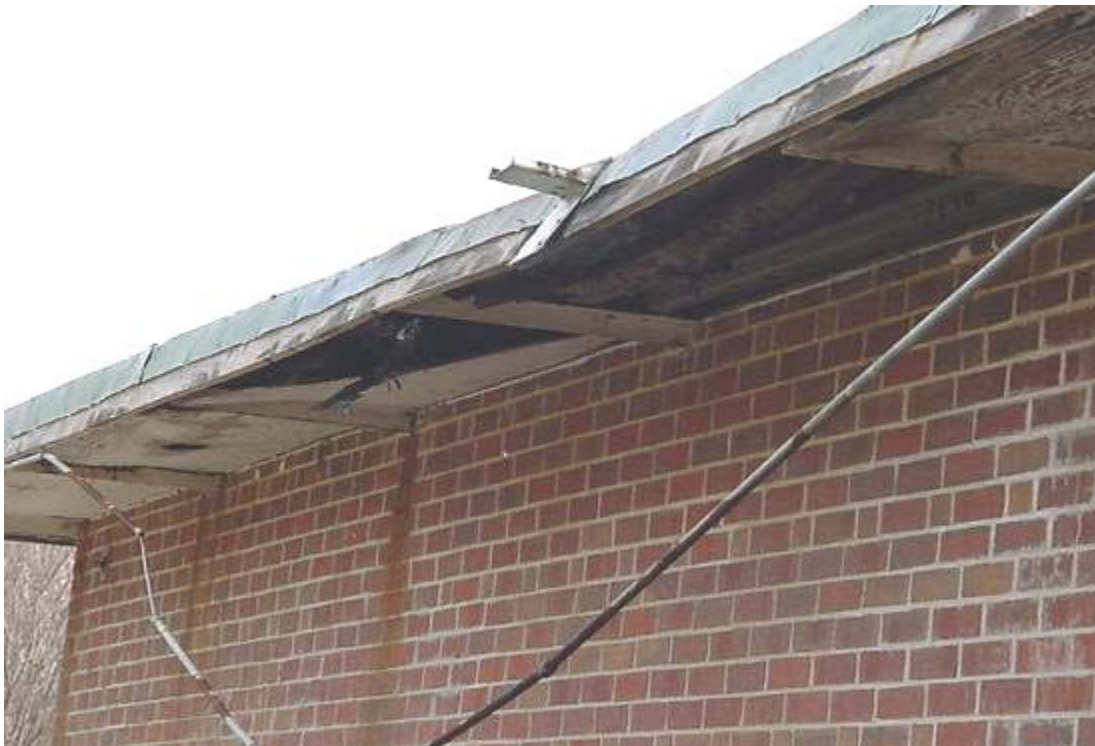
Picture 6

Severely Rotted Roof Eave, Note Hanging Utility Cable

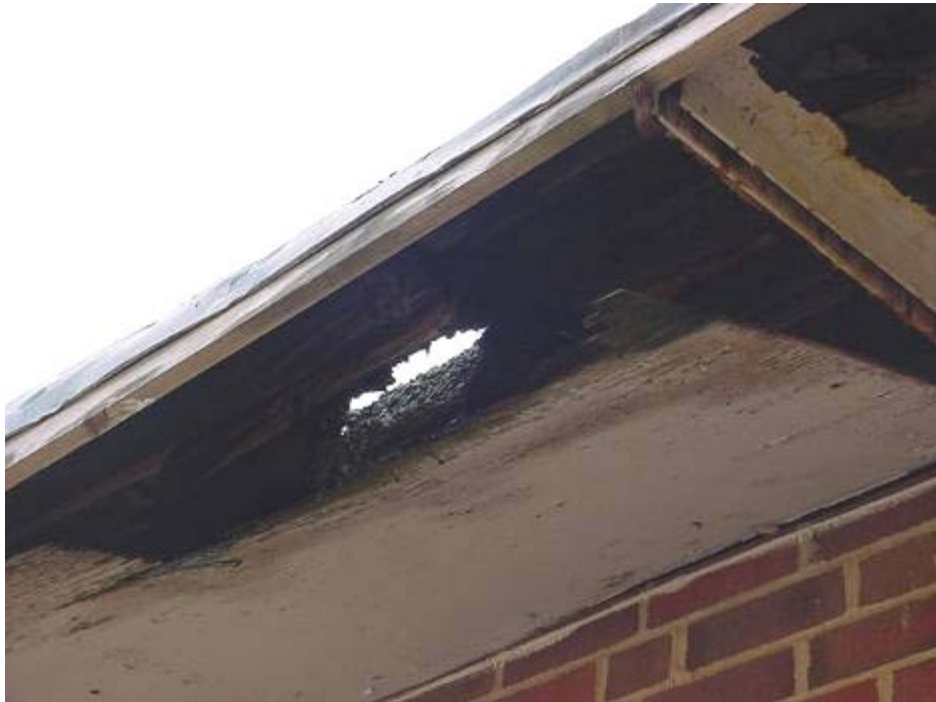
Picture 7

Severely Rotted Roof Eave

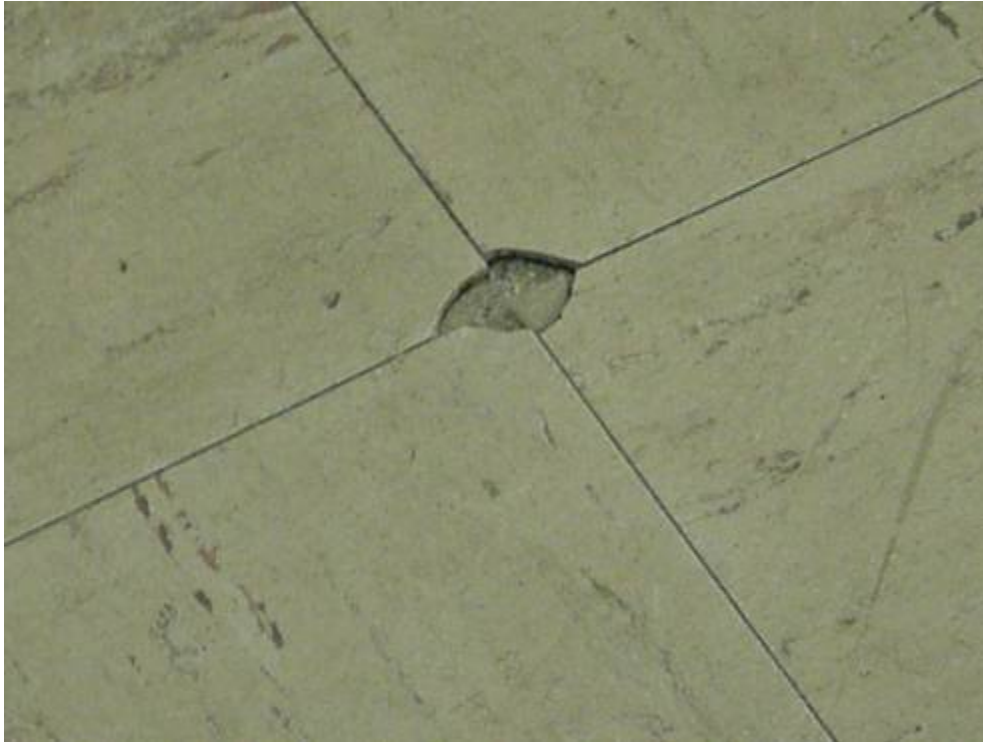
Picture 8

Several other conditions that can affect indoor air quality were observed during the assessment. As indicated in Appendix A, current roof leaks have loosened floor tiles in several areas (Pictures 8 and 9). Due to the age of the building it is likely that the floor tiles contain asbestos. Intact asbestos-containing materials do not pose a health hazard. If damaged, asbestos-containing materials can be rendered friable and become aerosolized. Where asbestos-containing materials are found damaged, these materials should be removed or remediated in a manner consistent with Massachusetts asbestos remediation laws (MDLI, 1993).

Damaged Floor Tile

6. Remediate any damaged/friable asbestos containing materials in conformance with all applicable Massachusetts’ asbestos abatement and hazardous materials disposal laws.

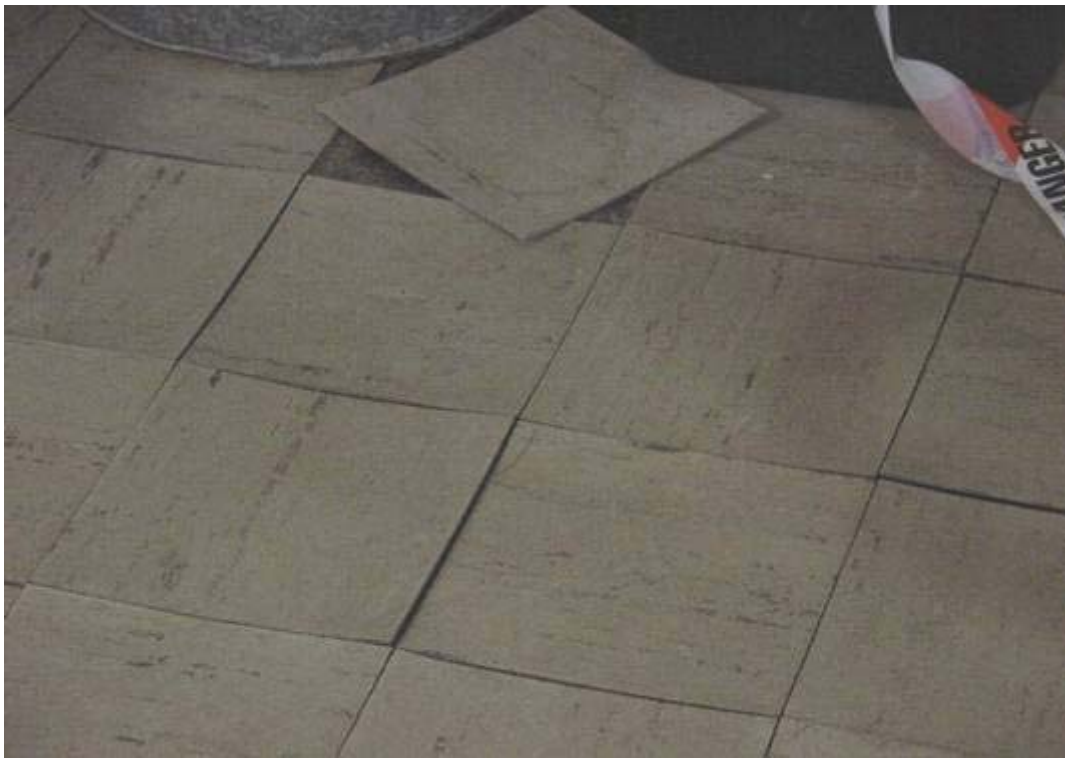
Picture 9

Loose/Lifting Floor Tiles

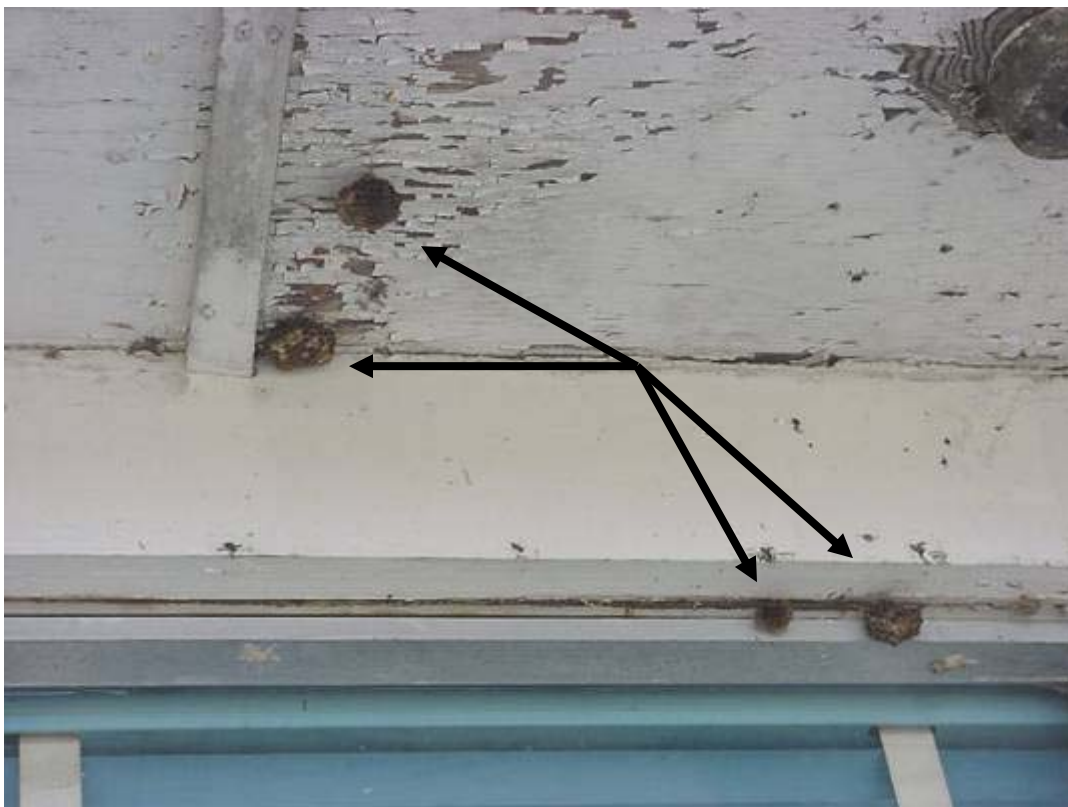
Picture 10

As indicated in the previous report the building has experienced infestation of hornets/wasps (MDPH, 2003). During a perimeter inspection of the exterior of the building as part of the current assessment, CEH staff observed over *seventy* hornets/wasps nest along the rear of the building alone (Picture 10). CEH staff observed several spray cans of pesticides in work areas. Insecticides contain chemicals that can be irritating to the eyes, nose and throat. Under current Massachusetts law the principles of integrated pest management (IPM) must be used to remove pests in state buildings and grounds (Mass Act, 2000). Although not a state office building, it is highly recommended that town officials contact a licensed exterminator to design and implement an IPM plan to address this issue.

Hornets/Wasps Nests on Exterior of Building (Rear)

10. Contact a licensed extermination firm to design and implement an integrated pest management (IPM) plan to rid this building of pests. A copy of the IPM recommendations can be downloaded from the Internet at http://www.state.ma.us/dfa/pesticides/publications/IPM_kit_for_bldg_mgrs.pdf.
